MHT No. B-4625

MARYLAND INVENTORY OF HISTORIC BRIDGES HISTORIC BRIDGE INVENTORY MARYLAND STATE HIGHWAY ADMINISTRATION/MARYLAND HISTORICAL TRUST

SHA Bridge No. BC 3211 Bridge name Cold Spring Lane over Herring Run
LOCATION: Street/Road name and number Cold Spring Lane
City/town Baltimore City Vicinity
County Baltimore
This bridge projects over: Road Railway Water X Land
Ownership: State County _ Municipal X Other
HISTORIC STATUS: Is bridge located within a designated historic district? YesNo XNo XNo XNo X
National Register-listed district National Register-determined-eligible district Other
Name of district
BRIDGE TYPE:
Timber Bridge:
Beam Bridge Truss -Covered Trestle Timber-And-Concrete
Stone Arch Bridge
Metal Truss Bridge
Movable Bridge:
Swing Bascule Single Leaf Bascule Multiple Leaf Pontoon
Metal Girder :
Rolled Girder Rolled Girder Concrete Encased Plate Girder Plate Girder Concrete Encased
Metal Suspension
Metal Arch
Metal Cantilever
Concrete X: Concrete Arch_X Concrete Slab Concrete Beam Rigid Frame
Other Type Name

B-4625
Bridge BC 3211
Cold Spring Lane over Herring Run
Baltimore City
Baltimore East Quad

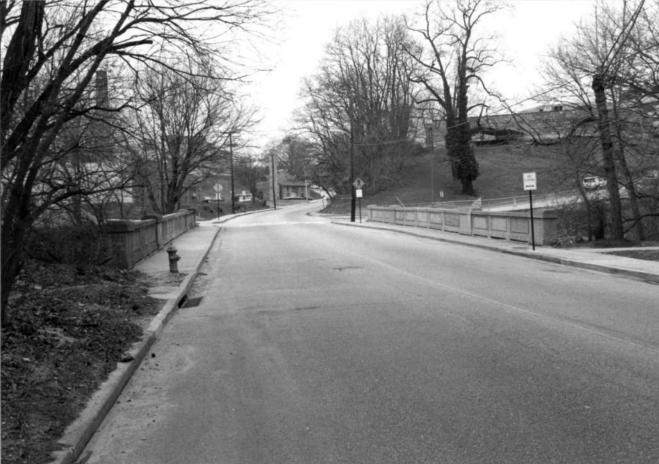
Name 2211 - COLD SPRING LANE OVER NERRING ! County/State BALTIMURE CITY/MO
Name of Photographer TIM SCHOEN
Date 1195
Location of Negative SHR
Description EAST APPROACH
°
Number 25 of 36 5

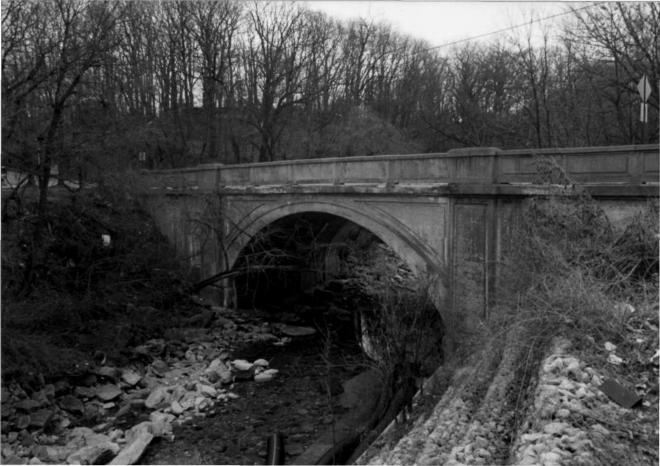
County/S	3211-COLD SPRING LANE OVER HERRINGRUM
Name of	Photographer TVM SCHUEN
Date	1/95
Location	of Negative SHA
Descripti	on NORTH ELEVATION
2	6
Number	27 of 36 5

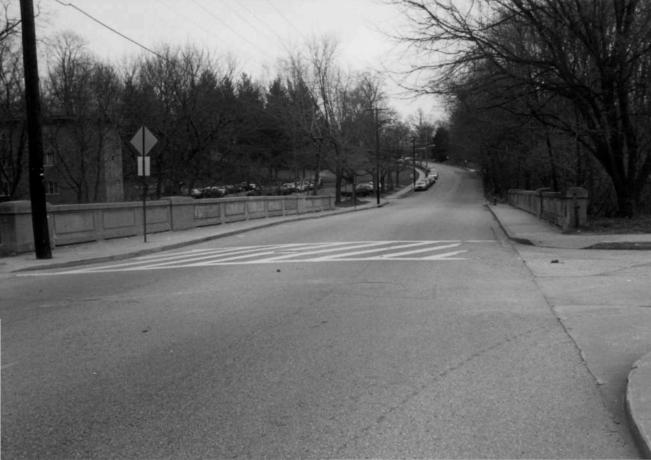
County/State	BALTIM	ORE CITYIA	10
Name of Pho	tographer	TIM SCHOE	~
Date	5		
Location of N	legative 💆	AK	
Description _	WEST	APPROACH	
4			
2	of 365	•

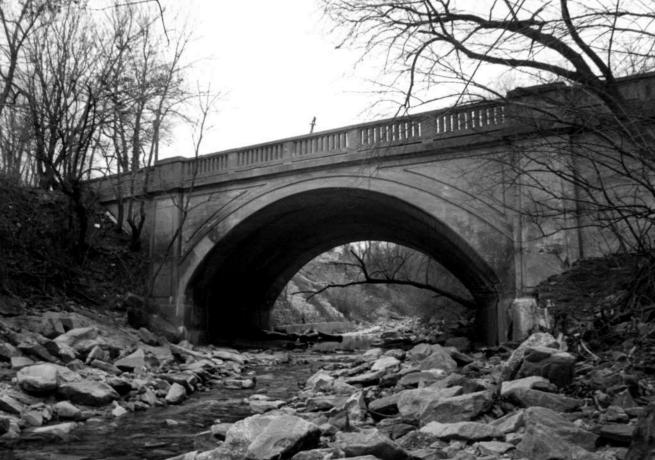
Name 3211-COLD SPRING LANE OVER HERRING RUN County/State BALTIMORE CITY/MD	
Name of Photographer TIM SCHOEN Date 1 95	-
Location of Negative SHA	
Description SOUTH EVENATION	
Number 27 of 35 5	-
